FOR IMMEDIATE RELEASE

March 23, 2011

+VG Architects - Century limestone landmark at St. Michael Catholic School in Belleville being restored

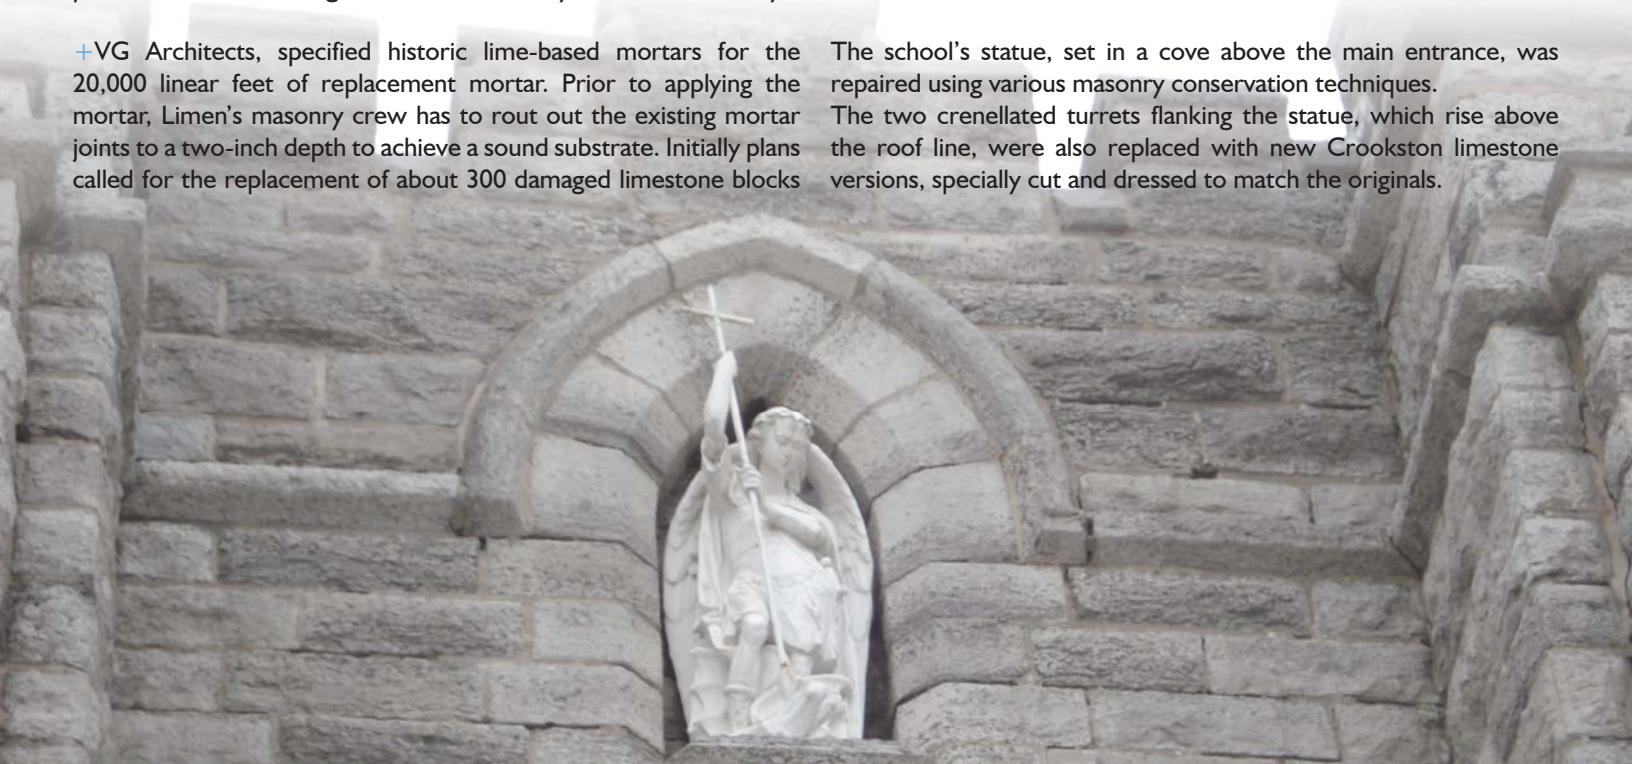
The statue at the front of the 100-year-old St. Michael Catholic School in Belleville was restored along with the rest of the building. The contractor even found the original quarry site to match the limestone perfectly. The Algonquin Lakeshore Catholic District School Board is going the extra mile to restore its early 20th century limestone school, a landmark on the main street of Belleville.

The school’s statue, set in a cove above the main entrance, was repaired using various masonry conservation techniques. The two crenellated turrets flanking the statue, which rise above the roof line, were also replaced with new Crookston limestone versions, specially cut and dressed to match the originals.
